# UNDERWATER BRIDGE INSPECTION REPORT

STRUCTURE NO. 7248

RED LAKE RIVER

DISTRICT 2 - PENNINGTON COUNTY

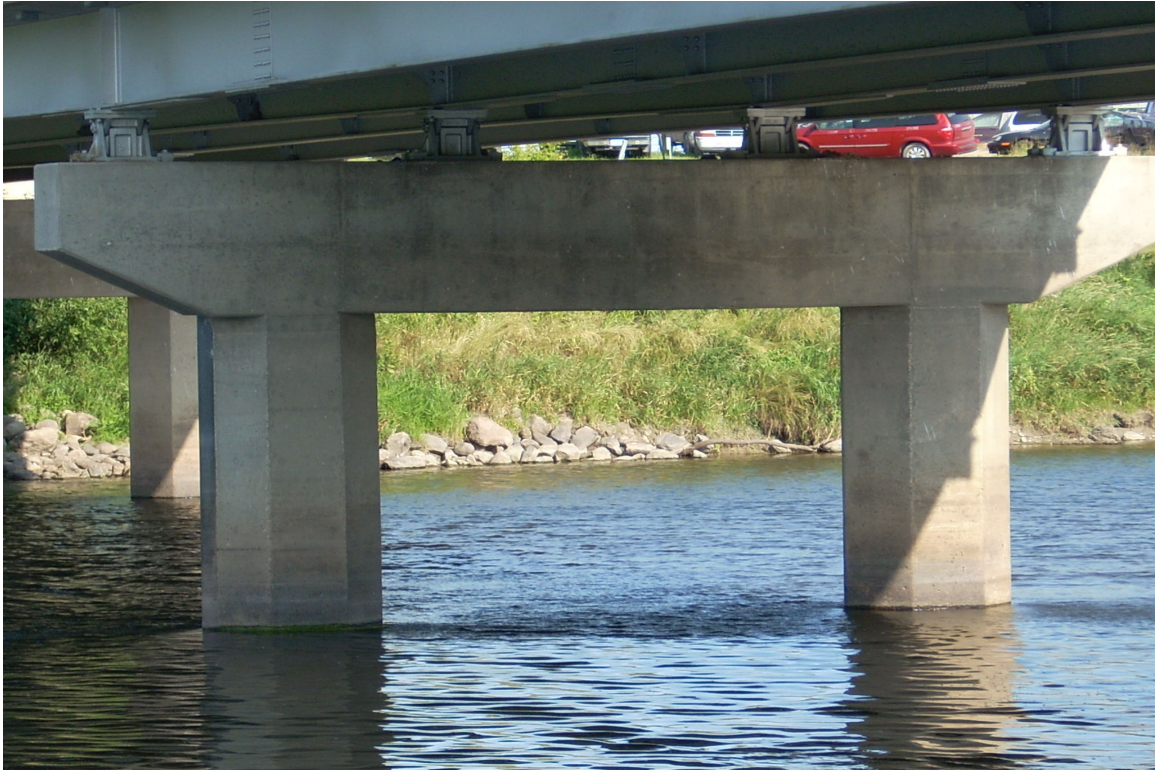
- (A) A scour pocket, 3 feet in radius with a depth of 1 foot, was observed at the upstream nose of Pier 2. The scour pocket exposed the top of the footing at 5.7 feet below the waterline with no vertical exposure.

Photograph 3. View of Pier 2, Looking Southeast.

Determine the significance of the footing exposure at Pier 2 by reviewing the design drawings to determine if the pier footings are founded on piles. If the columns are founded on piles, monitor the extent of footing exposure during future inspections. If the columns are founded on spread footings, then countermeasures may be required.

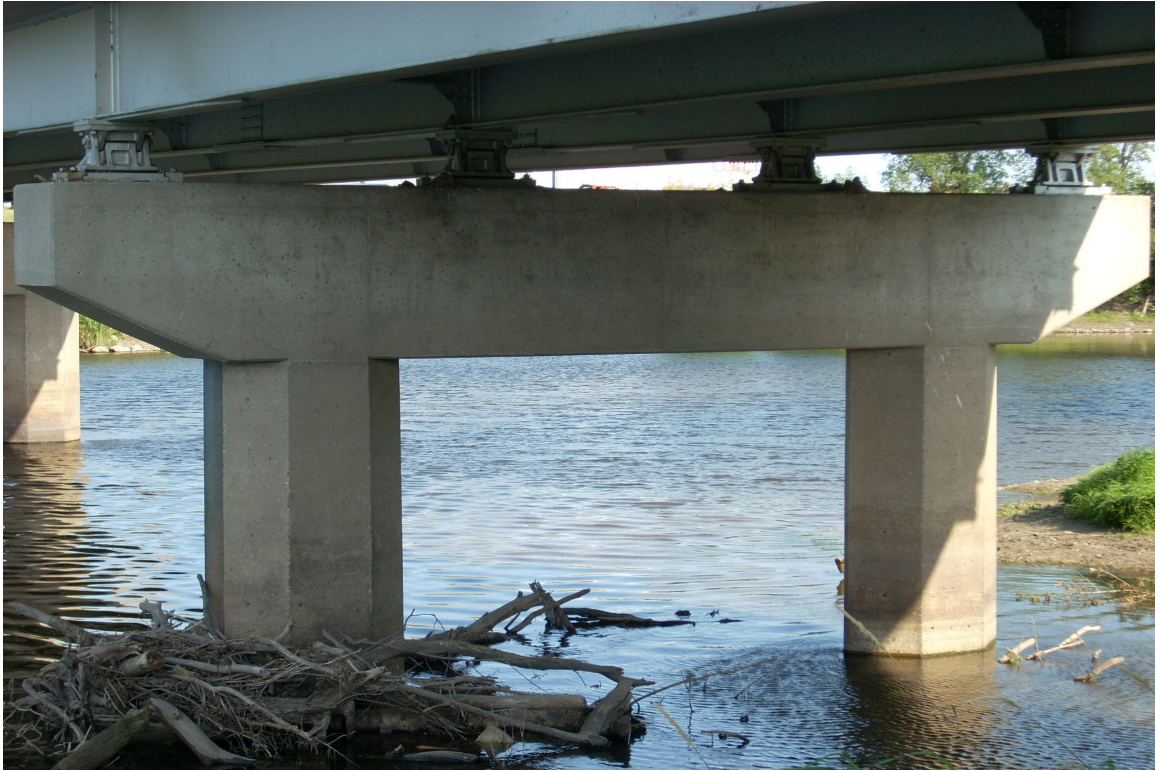
Photograph 5. View of Timber Debris at Pier 1, Looking Southwest.

Remove the accumulations of timber debris at Piers 1 and 2 to eliminate the potential for continued accumulation and to halt any scour or erosion influenced by the accumulations.

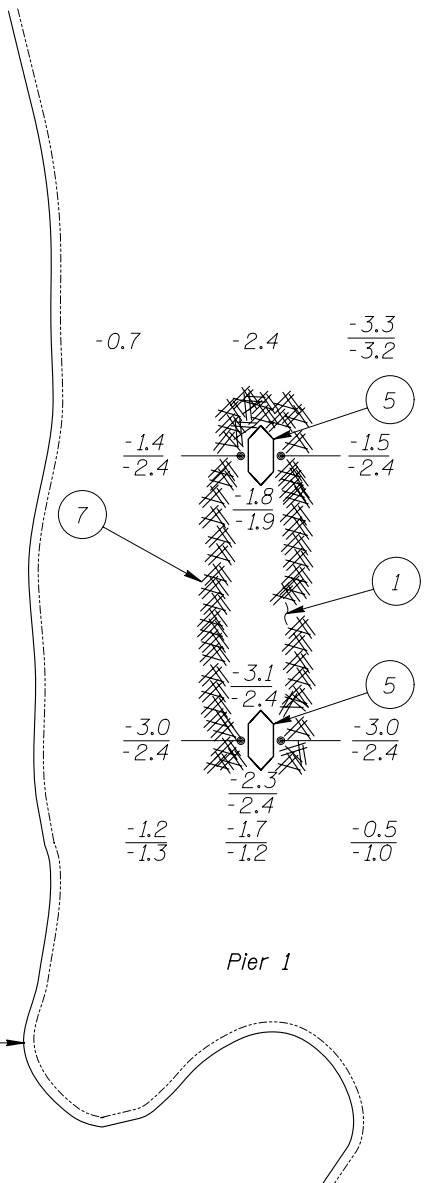
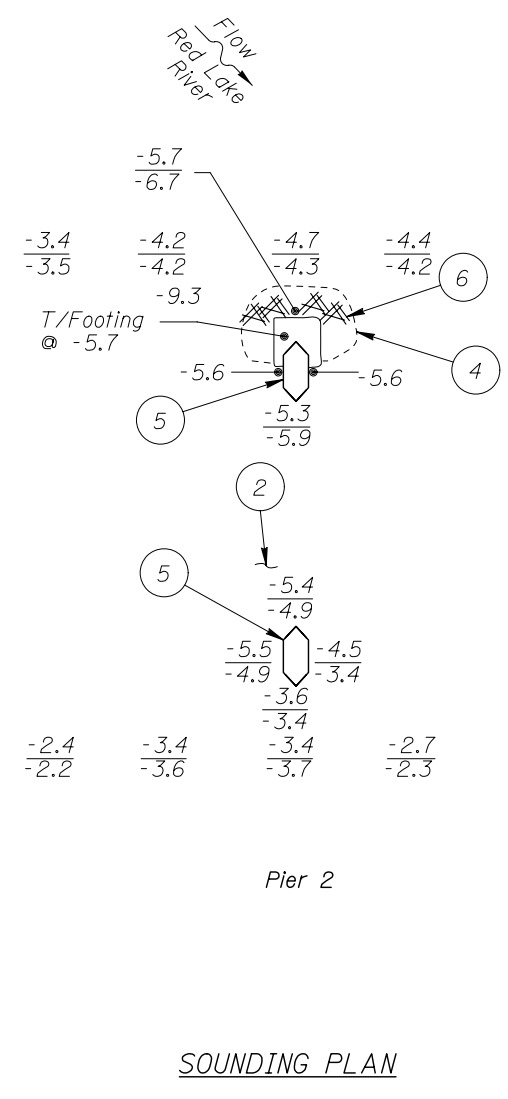
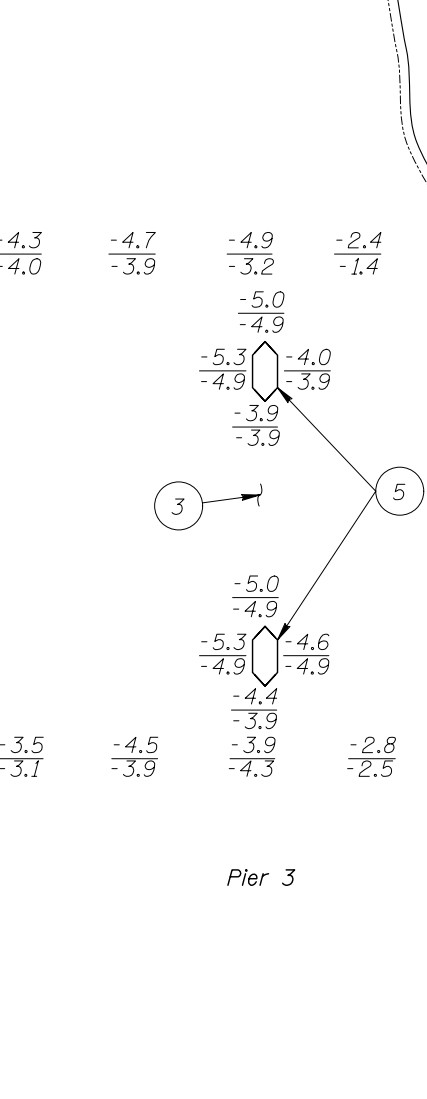
<b>MINNESOTA DEPARTMENT OF TRANSPORTATION UNDERWATER BRIDGE INSPECTION</b>		
STRUCTURE NO. 7248 OVER THE RED LAKE RIVER DISTRICT 2, PENNINGTON COUNTY		
INSPECTION AND SOUNDING PLAN		
Drawn By: PRH	<b>COLLINS ENGINEERS</b>	Date: AUGUST, 2007
Checked By: MDK		Scale: NTS
Code: 52210161		Figure No.: 1

TYPICAL END VIEW OF PIERS  
Presence or absence of piles could not be determined.

- The channel bottom material consisted of soft, silty infill with up to 2 feet of probe rod penetration around Pier 1.
- The channel bottom material at Pier 2 consisted of fine sand and random cobbles of up to 1 foot in diameter with up to 1 foot of probe rod penetration.
- The channel bottom material consisted of fairly firm sandy gravel with 3 to 6 inch diameter cobbles and a probe rod penetration of up to 6 inches around Pier 3.
- A scour pocket, 3 feet in radius with a depth of 1 foot, was observed at the upstream nose of Pier 2. The scour pocket exposed the top of the footing at 5.7 feet below waterline with no vertical exposure.
- Light scaling was observed around all columns from 1 foot above to 3 feet below the waterline with 1/4 inch of maximum penetration.

- A light accumulation of timber debris consisting of 6 inch diameter or smaller branches was observed at upstream nose of the upstream column of Pier 2 from channel bottom up 2 feet. The debris accumulation was 10 feet long (E-W) and 5 feet wide (N-S).
- A heavy accumulation of timber debris consisting of 12 inch diameter or smaller logs and branches was observed at upstream end of upstream column and along both faces to the downstream column of Pier 2. The debris extended from channel bottom to 2 feet max above the waterline, and up to 6 feet off pier faces and 8 feet off upstream nose.

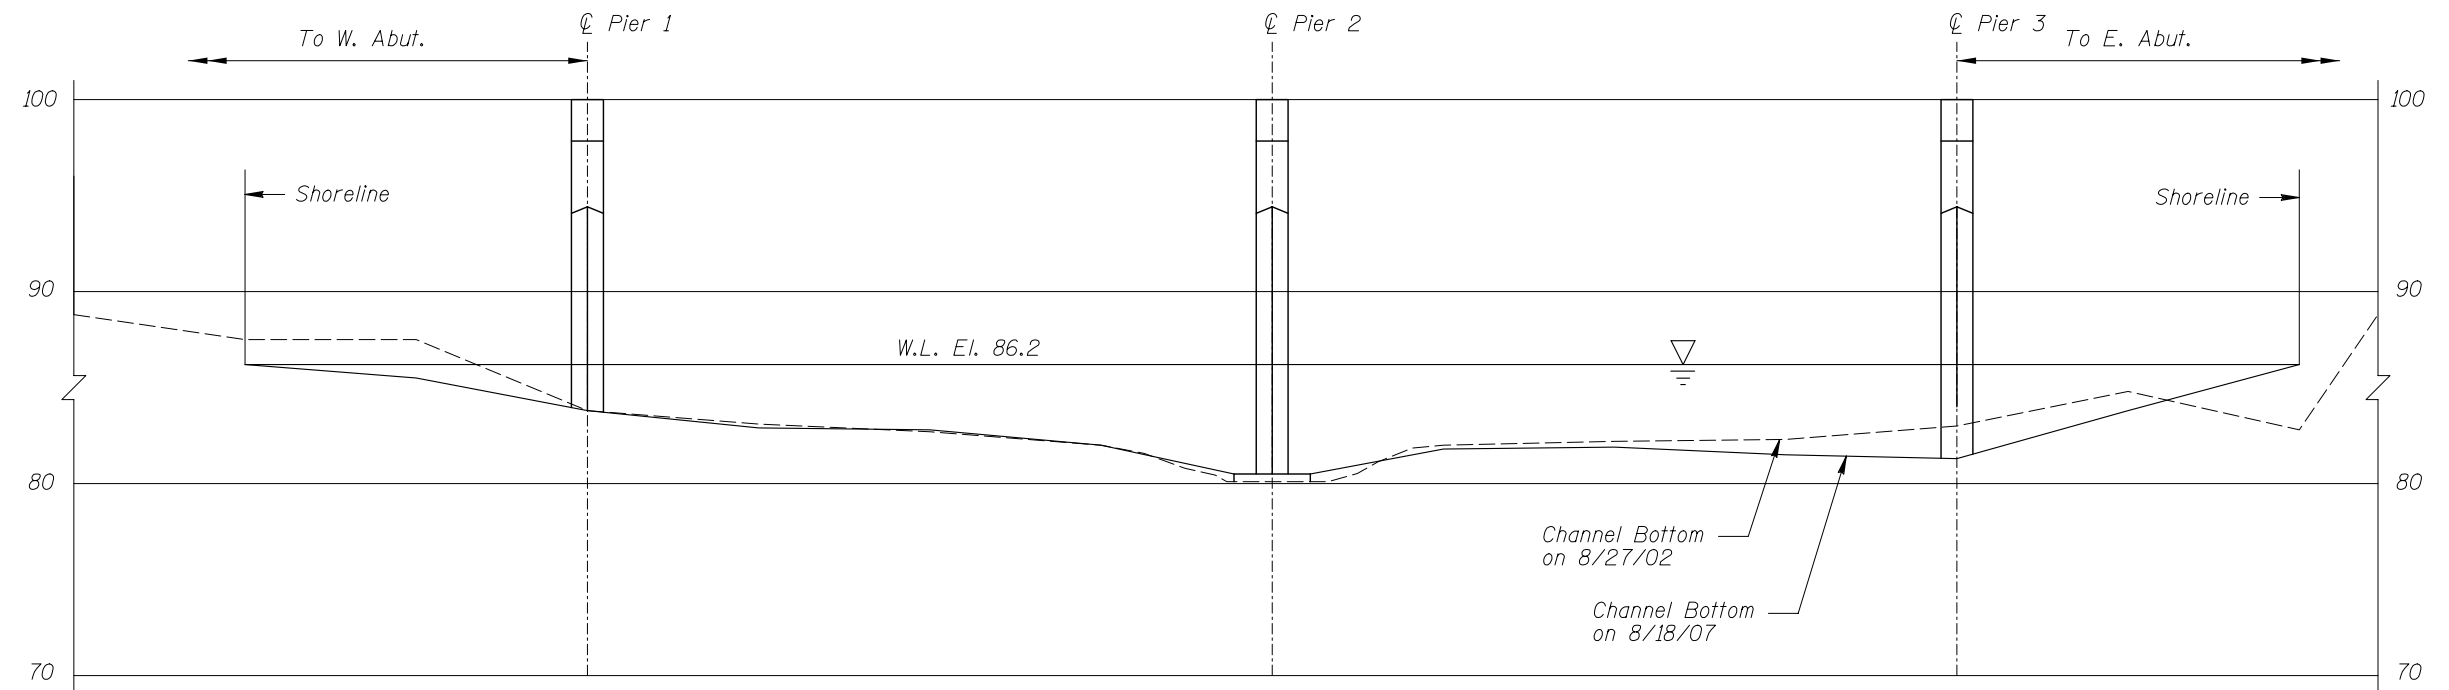
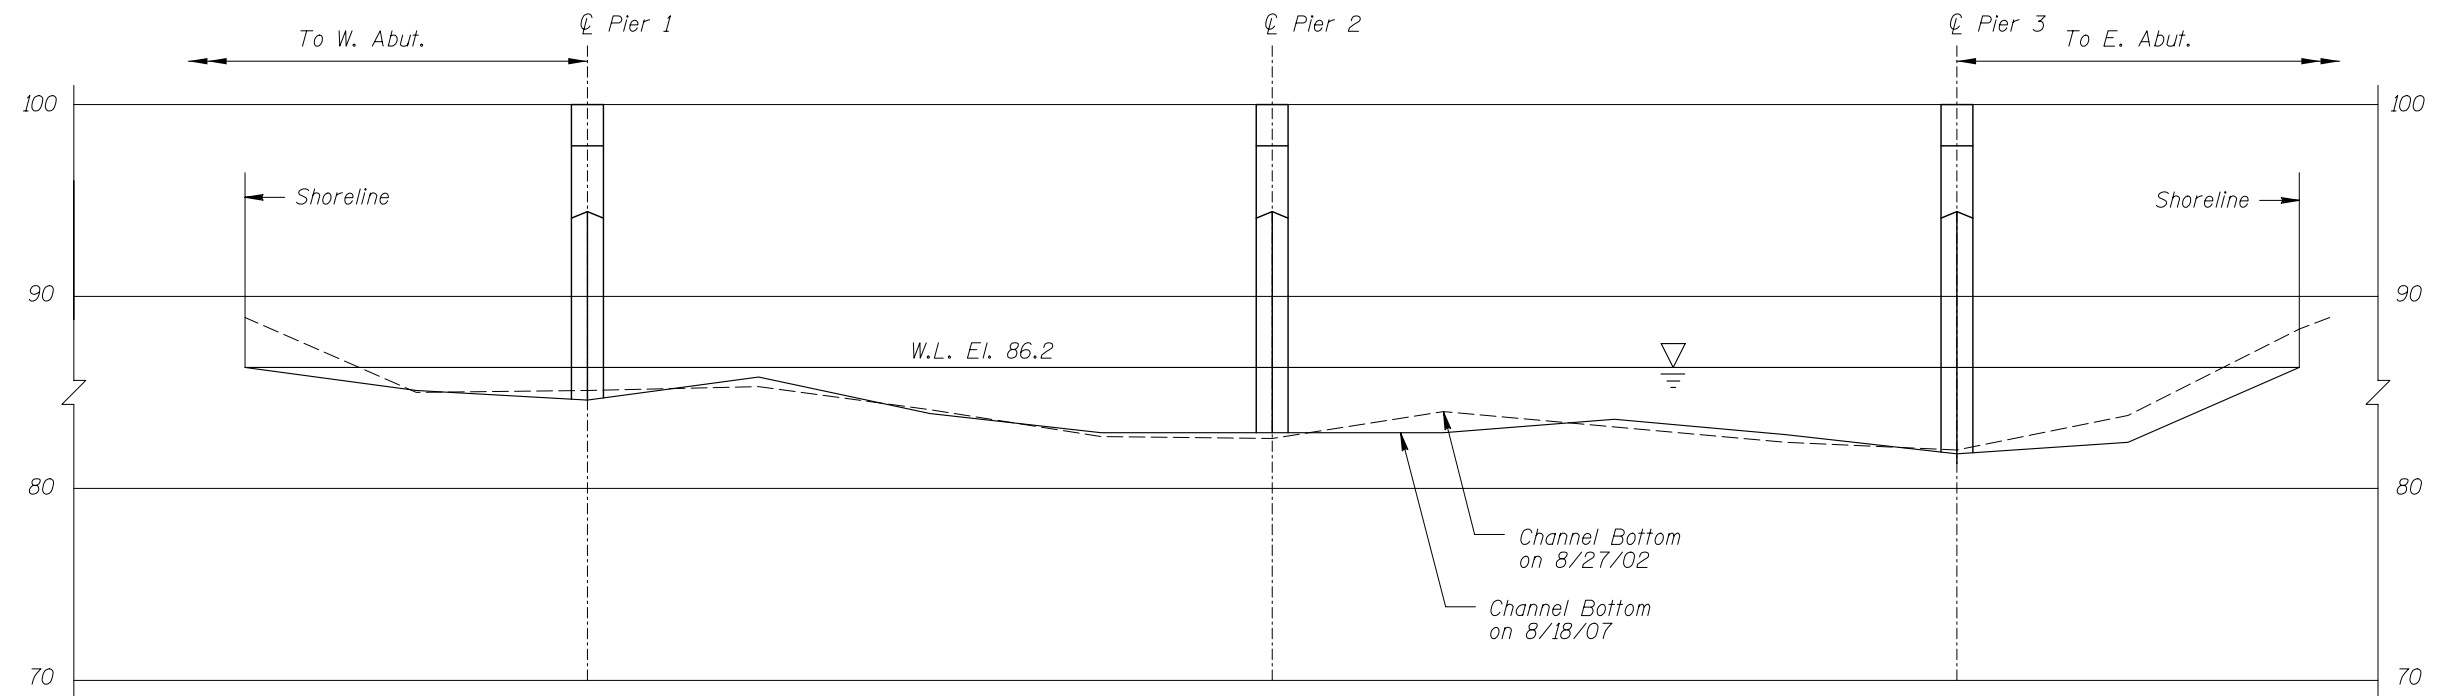
**UPSTREAM FASCIA PROFILE**  
Vertical Scale: 1"=10'-0"

**DOWNSTREAM FASCIA PROFILE**  
Vertical Scale: 1"=10'-0"
